DEPARTMENT OF TRANSPORTATION

Quality Assurance and Source Inspection

Contract #: 04-0120F4Cty: SF/ALA Rte: 80 PM: 13.2/13.9File #: 69.28**WELDING INSPECTION REPORT****Resident Engineer:**Pursell, Gary**Address:** 333 Burma Road**City:** Oakland, CA 94607**Report No:** WIR-003306**Date Inspected:** 25-Jul-2008**Project Name:** SAS Superstructure**OSM Arrival Time:** 630**Prime Contractor:** American Bridge/Fluor Enterprises, a JV**OSM Departure Time:** 1530**Contractor:** Zhenhua Port Machinery Company, Ltd (ZPMC), Changxing Island **Location:** Shanghai, China**CWI Name:** Hu Wei Qing and Zhashi**CWI Present:** Yes No**Inspected CWI report:** Yes No N/A**Rod Oven in Use:** Yes No N/A**Electrode to specification:** Yes No N/A**Weld Procedures Followed:** Yes No N/A**Qualified Welders:** Yes No N/A**Verified Joint Fit-up:** Yes No N/A**Approved Drawings:** Yes No N/A**Approved WPS:** Yes No N/A**Delayed / Cancelled:** Yes No N/A**Bridge No:** 34-0006**Component:** OBG and SAS Tower Fabrication**Summary of Items Observed:**

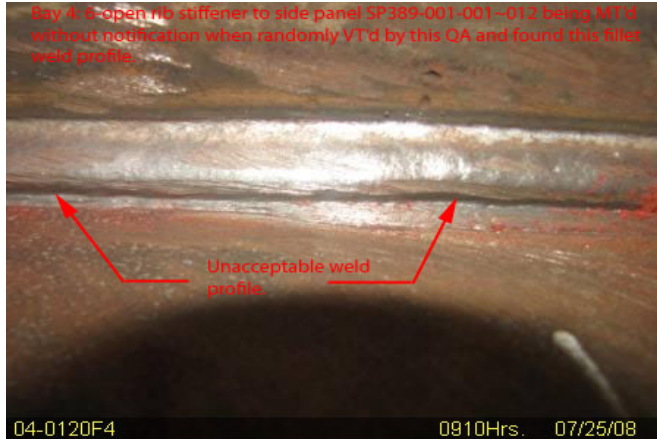
This QA observed ZPMC/NDE personnel perform MT without notification on 6-open rib stiffener to side panel SP389-001-001~012 and 7-open rib stiffener to SP388-001-001~014. During the ZPMC MT this QA, randomly perform VT on the fillet welds of side panels just mentioned and found unacceptable fillet weld profiles on both panels. This incident has been discussed with ZPMC CWI Huang Wen Pang and he agreed that some of the fillet welds profile need to be corrected. See photo below.

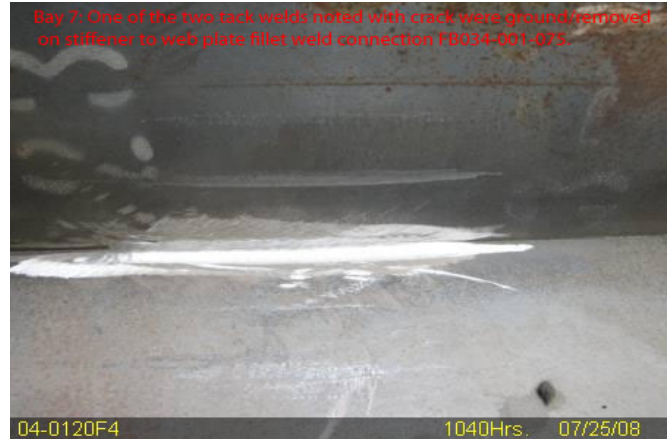
This QA was informed by ABF/QA Inspector Art Peterson regarding two cracked tack welds on stiffener to web plate fillet weld connection FB034-001-075. Upon arrival at Bay 7, this QA noted the two cracked tack welds have already ground/removed. Per ZPMC CWI Hu Wei Qing, they will do the MT on tack removal in the afternoon. See photo below.
